1995–2004—The following GM service bulletins confirm a pattern of engine intake manifold gasket defects, which are sometimes covered by a 6-year/100,000 km secret warranty. Here they are presented from the earliest to the latest per Alldata garage bulletin subscription I subscribe to:

Engine Coolant - Consumption/Leak

Bulletin No.: 01-06-01-007A

Engine Coolant Consumption or Coolant Leak
(Inspect For Material Degradation/Replace [Intake Manifolds](#))

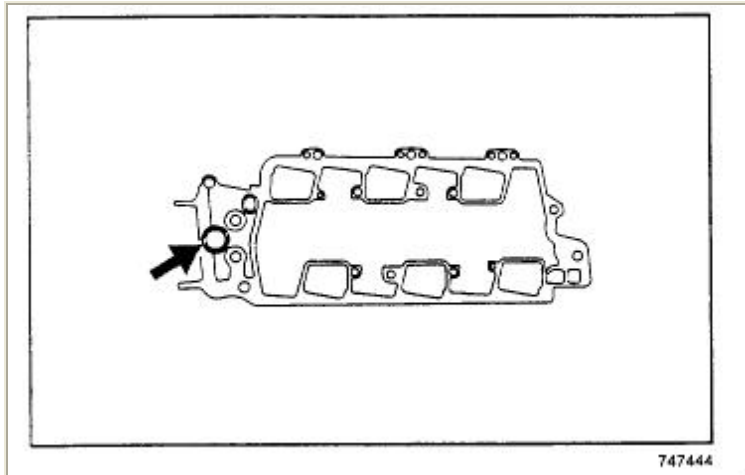
Upper intake manifold composite material may degrade around the EGR stove pipe and could result in an internal or external coolant leak.

2. Refer to the arrow in the illustration of the upper intake manifold above. Inspect the inner diameter of the EGR passage for signs of material degradation. Degradation will appear as "pitting" of the composite material in the EGR port passage.

3. If degradation of upper intake manifold composite material is found, replace the lower and upper intake manifolds with the following part numbers:
 - ^ Lower Intake - 24508923

- ^ Upper Intake - 17113136 (includes necessary upper intake plenum gaskets)
 - ^ Lower Intake Gasket - 12537197
4. Follow the lower and upper intake manifold installation instructions found in the Engine Unit Repair Section of the appropriate Service Manual.

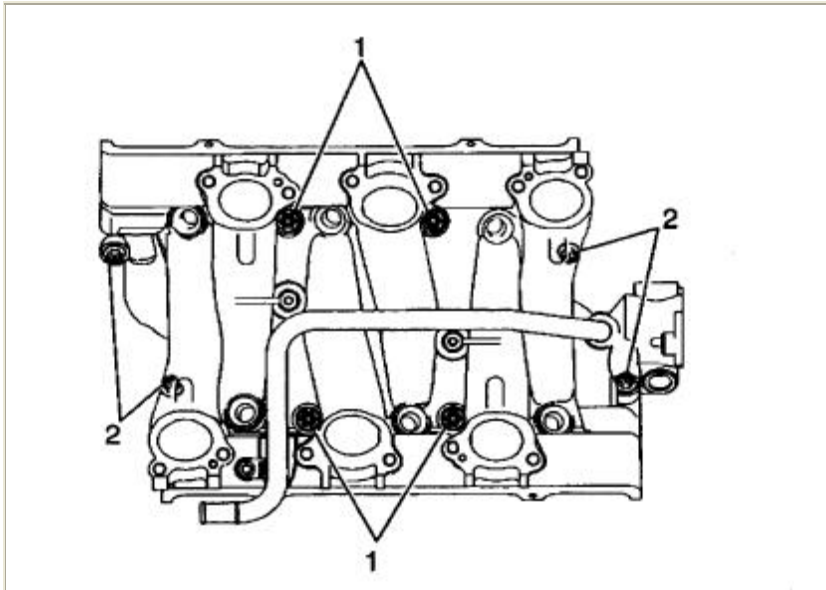
[Intake manifold](#) may be leaking allowing coolant, oil or both to leak from the engine.

Install a new design [intake manifold gasket](#). The material used in the gasket has been changed in order to improve the sealing qualities of the gasket. When replacing the gasket, the [intake manifold](#) bolts must also be replaced and torqued to a revised specification. The new bolts will come with a pre-applied threadlocker on them.

Notice An oil leak may result if the vertical bolts are not tightened before the diagonal bolts.

1. Tighten the vertical lower intake manifold bolts (1) to 7 N.m (62 lb in).
2. Tighten the diagonal lower intake manifold bolts (2) to 7 N.m (62 lb in).
3. Tighten the vertical lower intake manifold bolts (1) to 13 N.m (115 lb in).
4. Tighten the diagonal lower intake manifold bolts (2) to 25 N.m (18 lb ft).
